**Thermography Inspection at**  
**ABC Company**  
**123 Street, Philadelphia, PA 19124**  
**Sept. 13, 2011**  
**By**  
**William M. Paone**

**Job # PBC-11002**  
**Inspection Date: September 13, 2011**  
**Report Date: October 2, 2011**

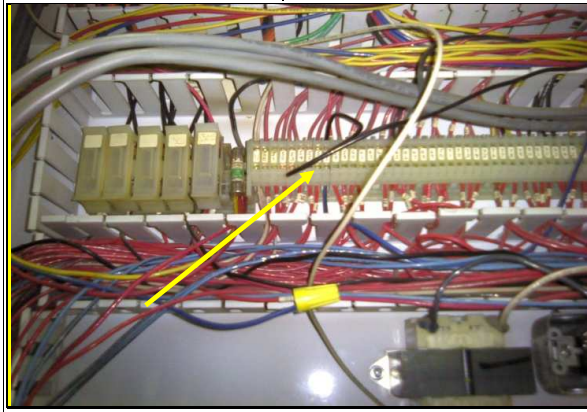
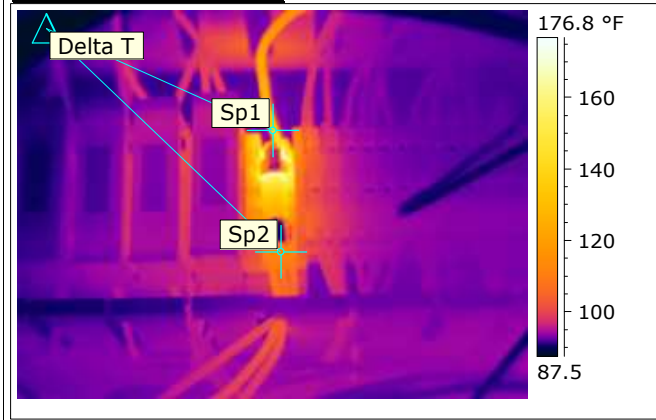
Location	Compressor Room
Location Description	Maintenance Shop
Equipment	PLC Panel
Fault	2

Sp1 Temperature	140.6 °F
Sp2 Temperature	111.8 °F
Delta T Value	28.8

**Priority: 2**

There is a 28.8 deg rise on the line conductor over the load side conductor

- Clean and tighten connections
- Check fuse clips for tightness

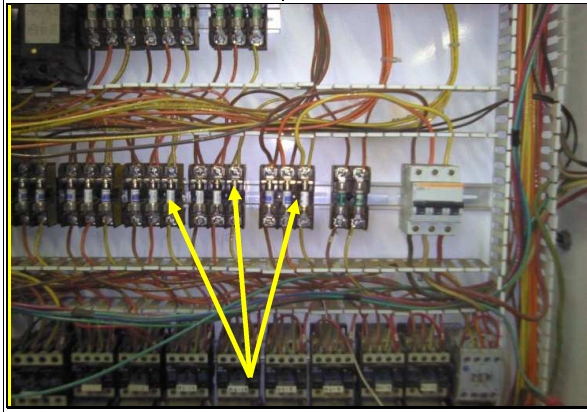
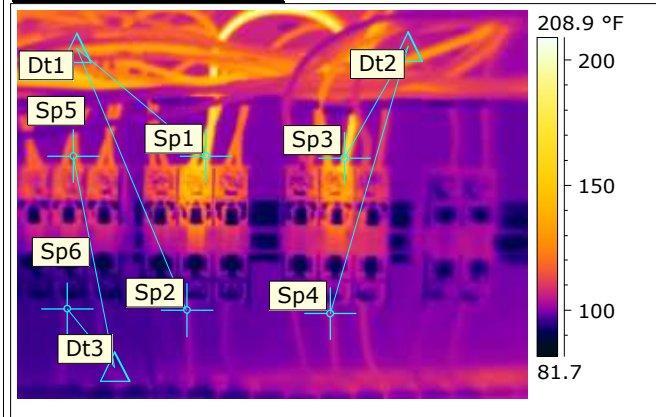
Location	Compressor Room
Location Description	Maintenance Shop
Equipment	PLC Panel
Fault	3

Sp1 Temperature	168.3 °F
Sp2 Temperature	101.6 °F
Sp3 Temperature	170.2 °F
Sp4 Temperature	105.7 °F
Sp5 Temperature	115.9 °F
Sp6 Temperature	98.3 °F
Dt1 Value	66.7
Dt2 Value	64.6
Dt3 Value	17.6

**Priority: 3**

- There is a 66.7 deg rise on the line side conductor over the load side (DT1)
- There is a 64.6 deg rise on the line side conductor over the load side (DT2)
- There is a 17.6 deg rise on the line side conductor over the load side (DT3)

Clean and tighten connections

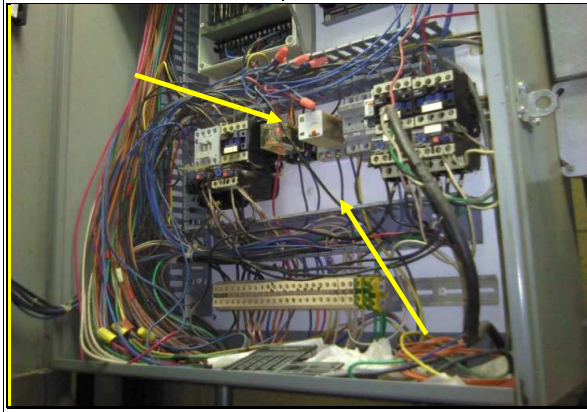
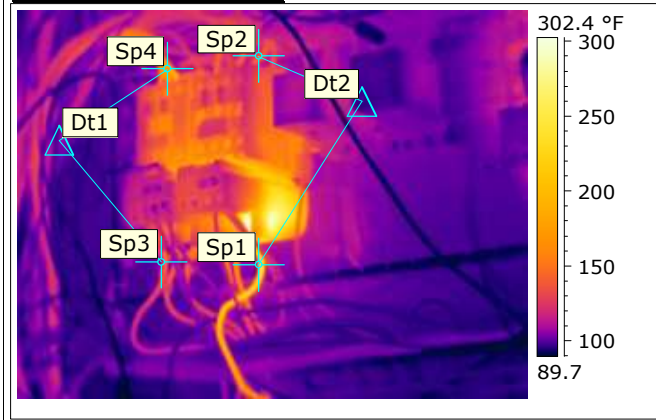
Location	Compressor Room
Location Description	Maintenance Shop
Equipment	Control Panel #6 Freezer
Fault	3

Sp1 Temperature	235.9 °F
Sp2 Temperature	142.8 °F
Sp3 Temperature	115.3 °F
Sp4 Temperature	182.8 °F
Dt1 Value	67.5
Dt2 Value	93.1

**Priority: 3**

There is a 67.5 deg rise on the line conductor over the load conductor (DT1)  
 There is a 93.1 deg rise on the load conductor over the line conductor (DT2)

Clean and tighten connections  
 Check for faulty devices
